# Inspection Report

**Property Address:**  
123 Serenity Lane  
NC

**Outlook Home Inspections, LLC**

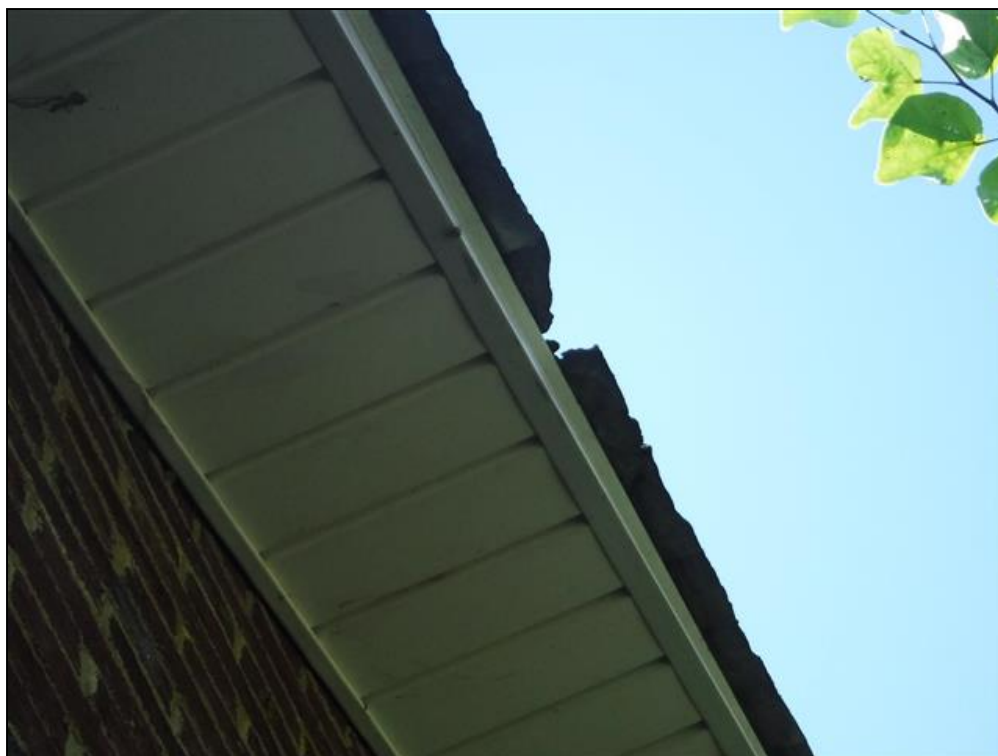
1.0 Item 1(Picture)

Loose and/or damaged shingle tabs were located at the rear gable located just above the master bedroom. A licensed roofing contractor should be consulted for evaluation and repair.

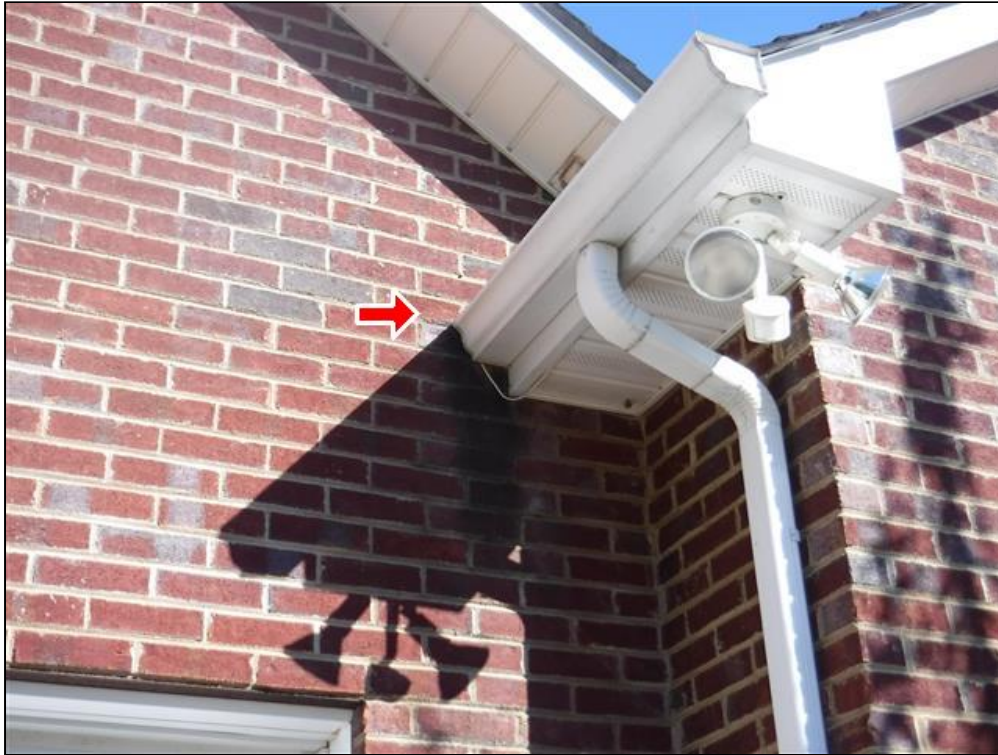
1.3 Item 1(Picture)

(1) Water stains on brick suggest that water is overflowing the gutter system in place above the right side of the garage door. A kickout flashing should be installed to prevent water intrusion and eventual damage to the masonry. A licensed roofing contractor should be consulted for evaluation and repair.

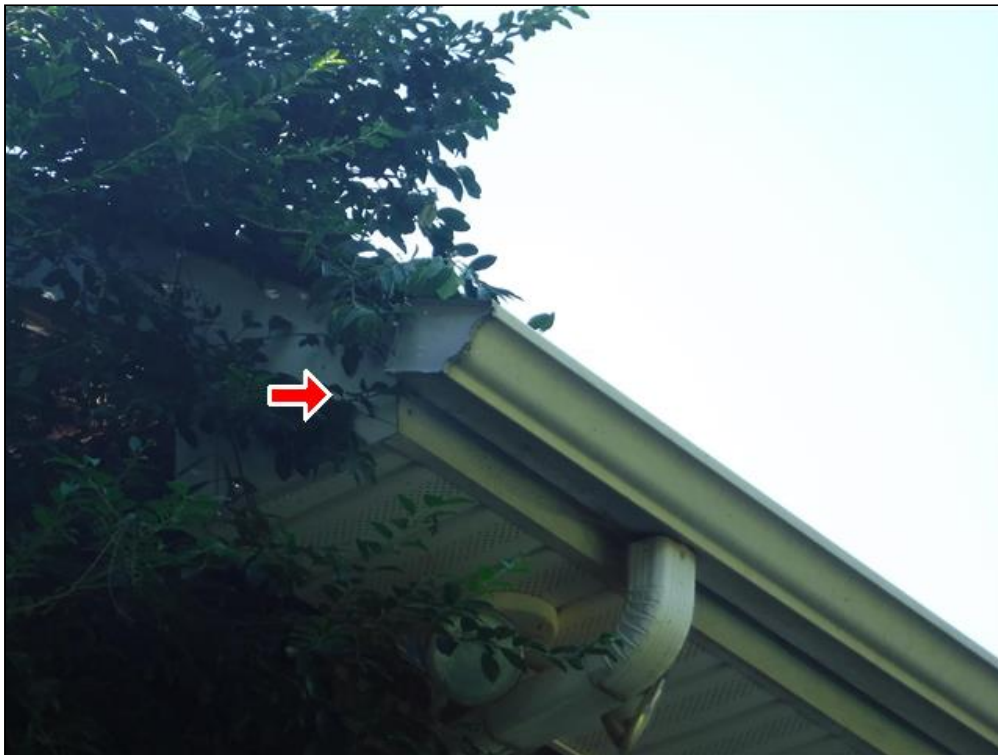
1.3 Item 2(Picture)

(2) Section of the gutter located at the rear, right side of the home has pulled away from the fascia. Water penetration that could result in damage could occur if not repaired. A qualified contractor or tradesman should perform repair.

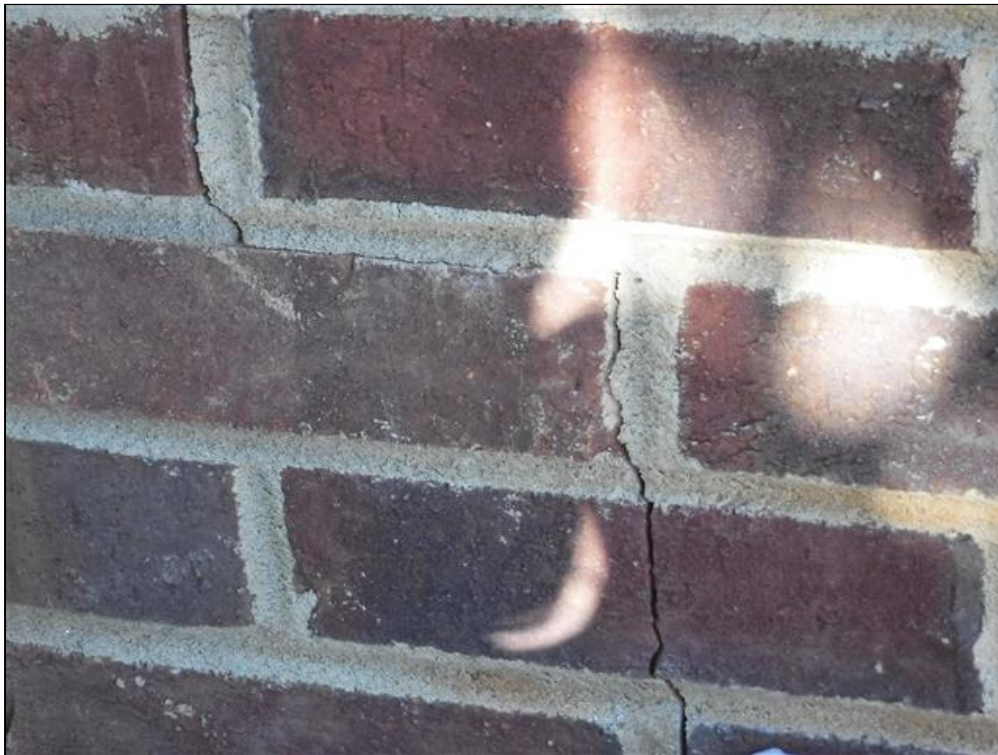
2.0 Item 1(Picture)

Measurable crack located in the brick veneer just to the right of the garage door entrance should be sealed to prevent moisture intrusion. A licensed general contractor should be consulted for further evaluation and to make necessary repair(s).

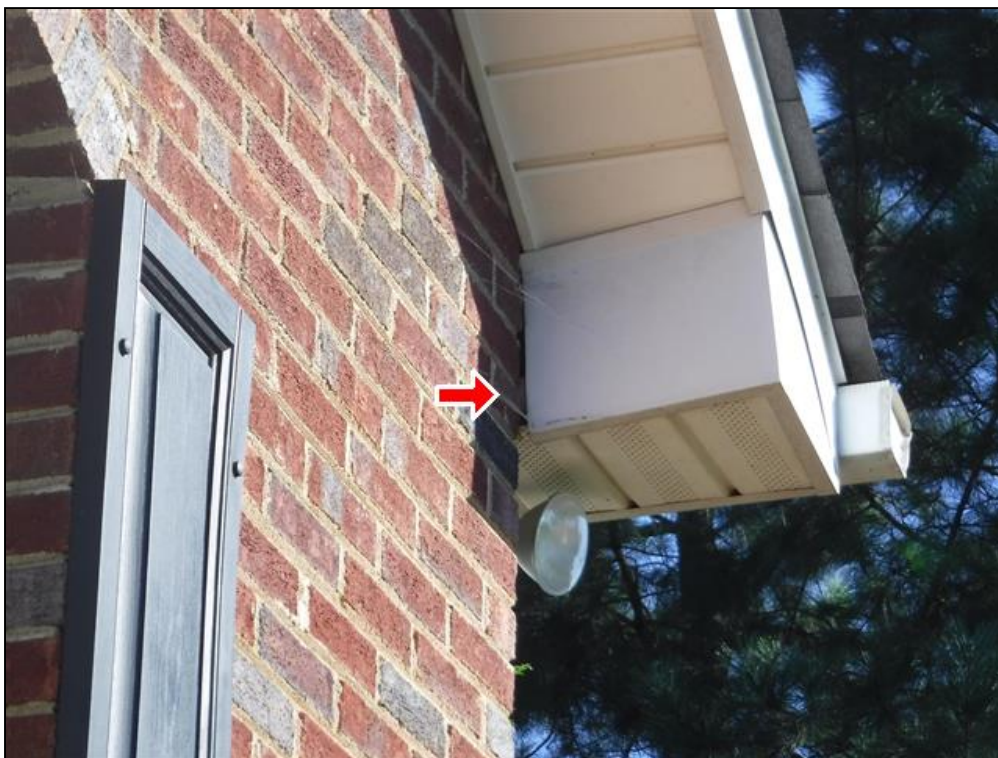
2.5 Item 1(Picture)

Piece of soffit located above far, right window in front of house is loose and needs to be reattached or replaced in order to prevent moisture and pest intrusion. A qualified contractor or tradesman should perform repair.

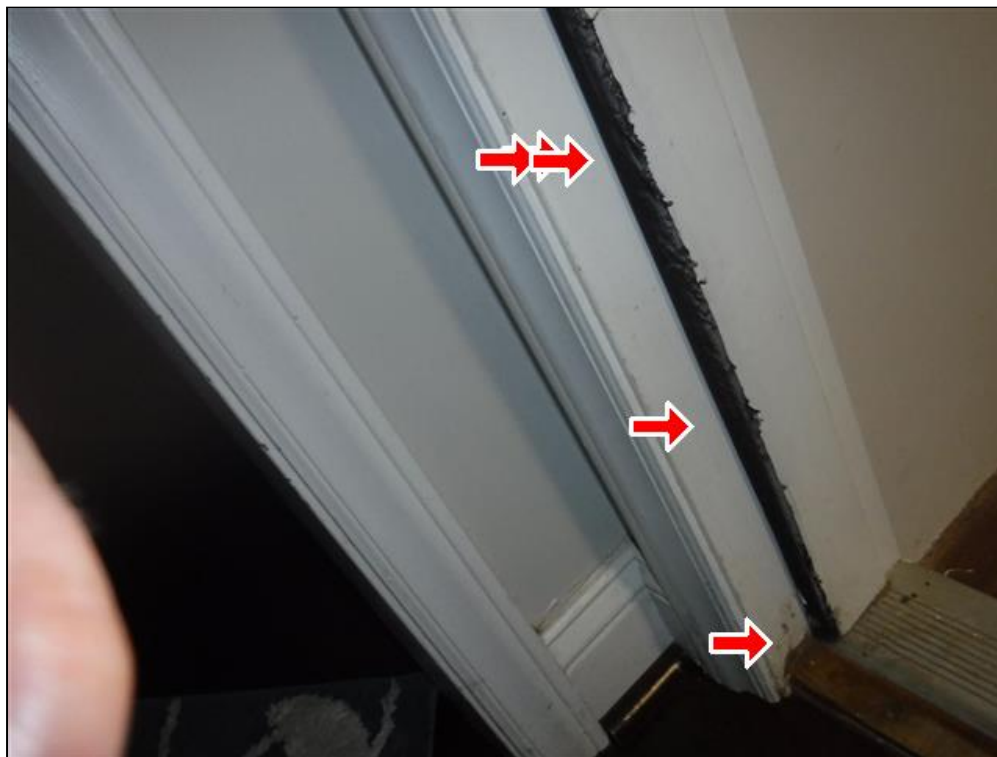
3.4 Item 1(Picture)

Weather stripping around door is damaged. Repair/replacement is recommended in order to provide adequate seal from outdoor elements. Repair should be made by qualified contractor or tradesman.

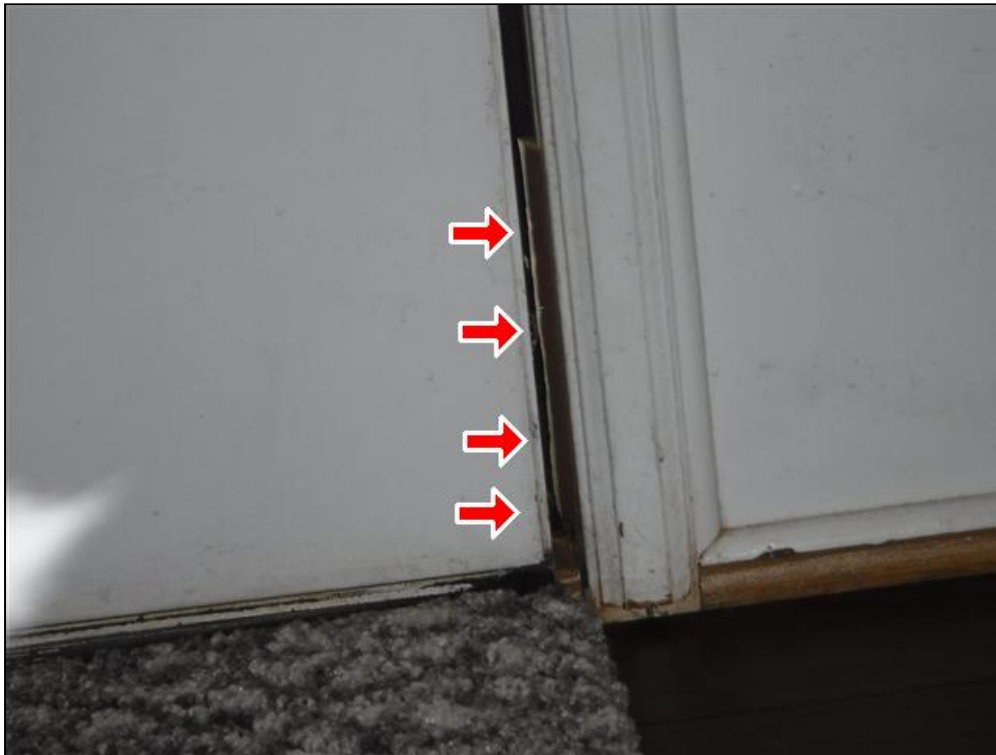
4.5 Item 1(Picture)

Weather stripping around both doors that exit to the exterior is damaged. Light from outside is clearly visible. This may lead to less efficiency of systems and general exposure to outer elements such as pests and moisture. A licensed contractor or qualified tradesman should be consulted for evaluation and repair.

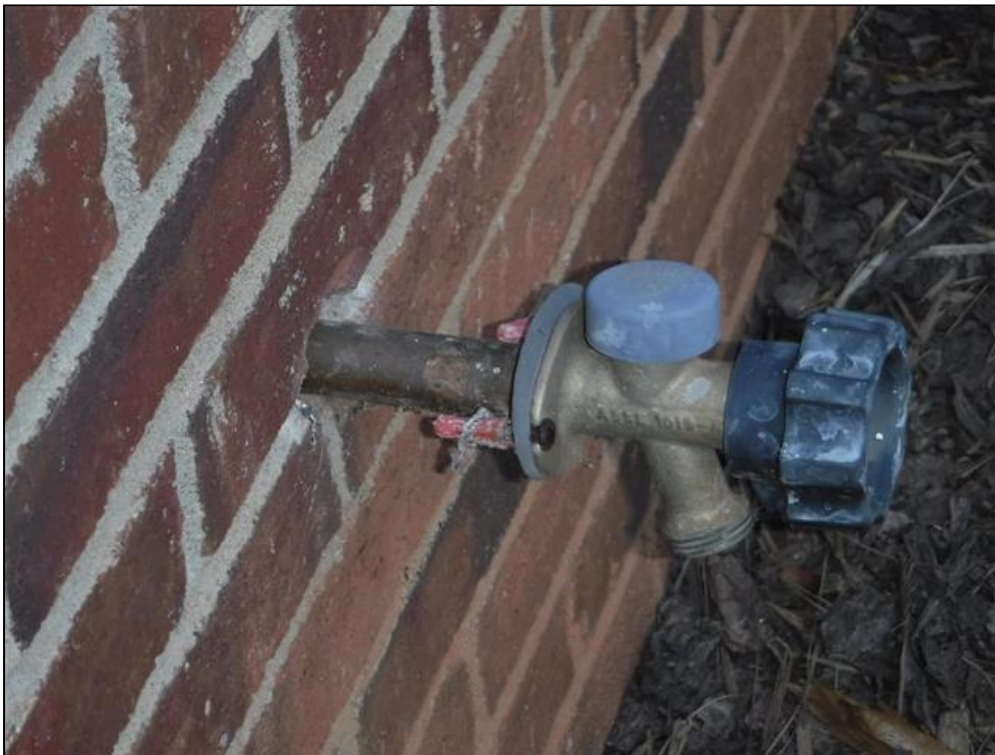
6.1 Item 1(Picture)

Hose bib located at rear of the home near the crawl space entrance has become detached from the wall. Repair needed to secure hose bib in place. A licensed plumbing contractor should perform repair.

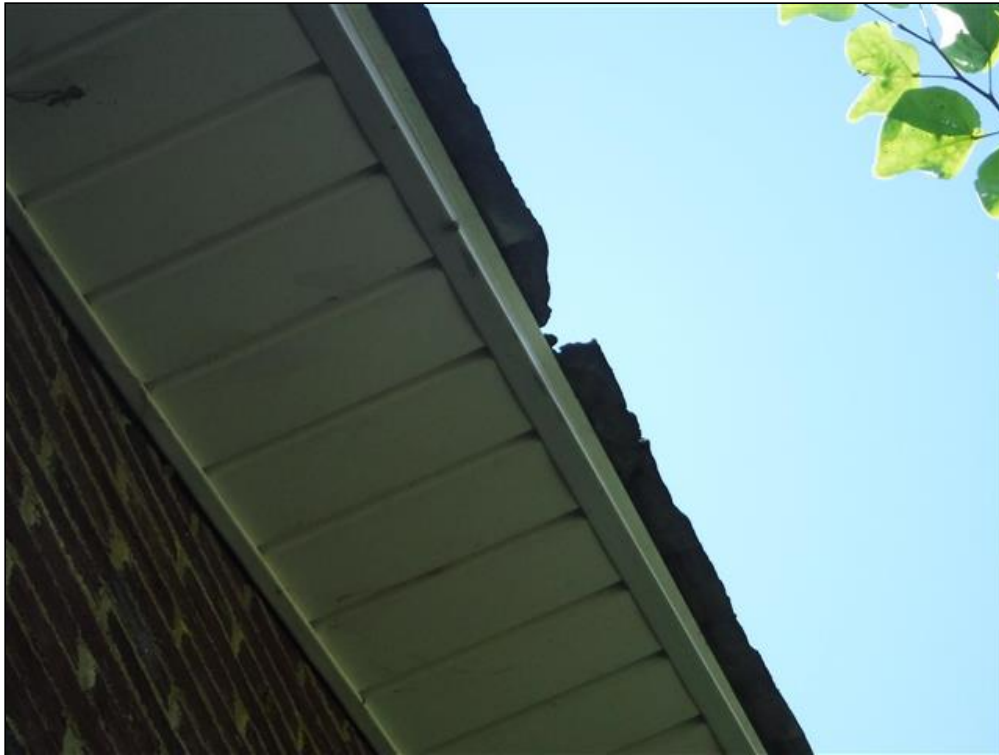
1.0 Item 1(Picture)

Loose and/or damaged shingle tabs were located at the rear gable located just above the master bedroom. A licensed roofing contractor should be consulted for evaluation and repair.

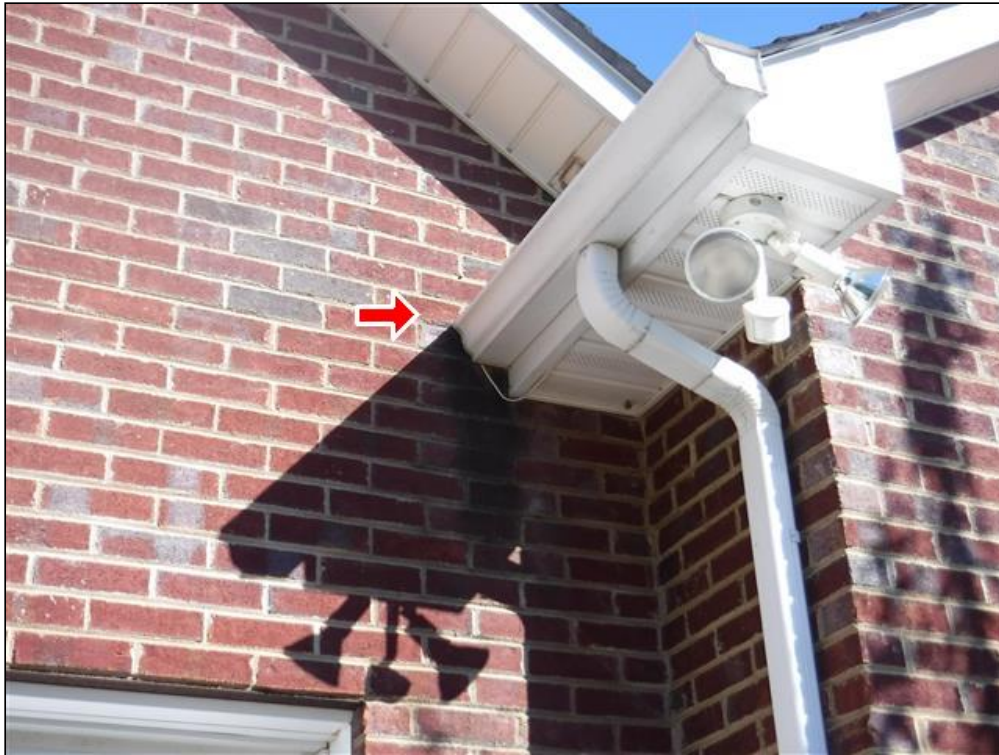
1.3 Item 1(Picture)

(1) Water stains on brick suggest that water is overflowing the gutter system in place above the right side of the garage door. A kickout flashing should be installed to prevent water intrusion and eventual damage to the masonry. A licensed roofing contractor should be consulted for evaluation and repair.

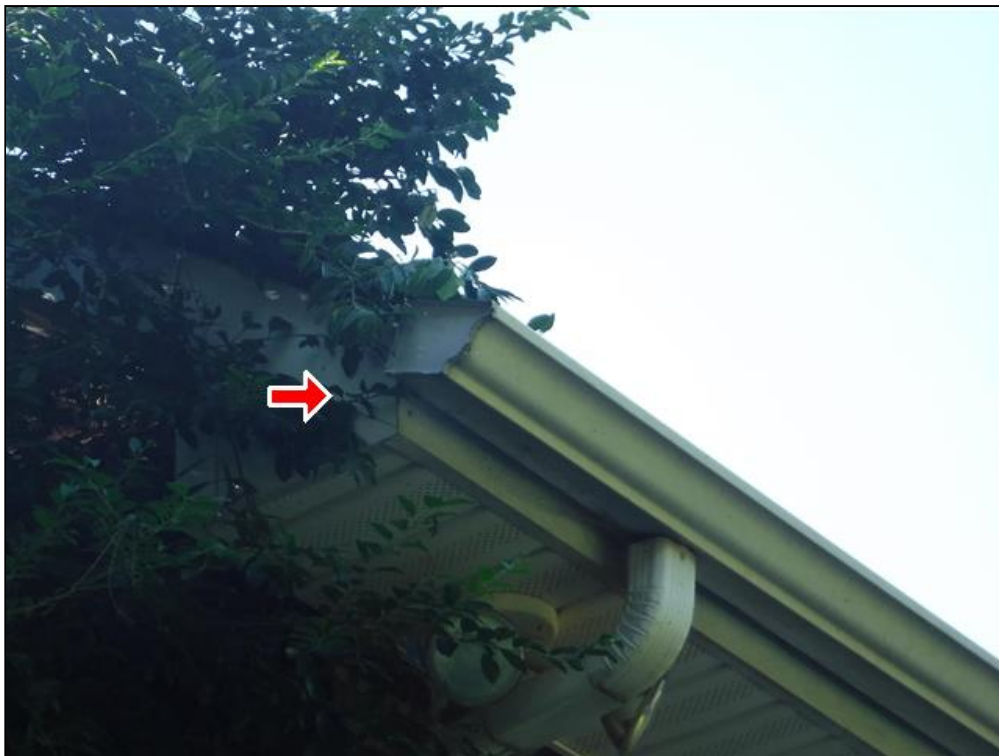
1.3 Item 2(Picture)

(2) Section of the gutter located at the rear, right side of the home has pulled away from the fascia. Water penetration that could result in damage could occur if not repaired. A qualified contractor or tradesman should perform repair.

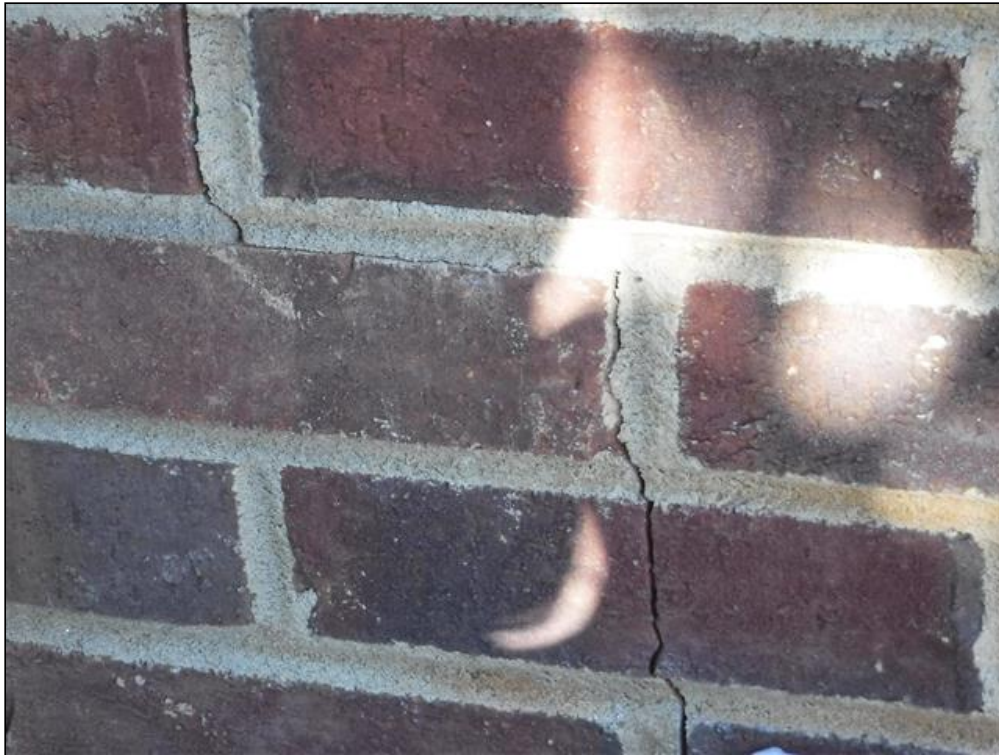
2.0 Item 1(Picture)

Measurable crack located in the brick veneer just to the right of the garage door entrance should be sealed to prevent moisture intrusion. A licensed general contractor should be consulted for further evaluation and to make necessary repair(s).

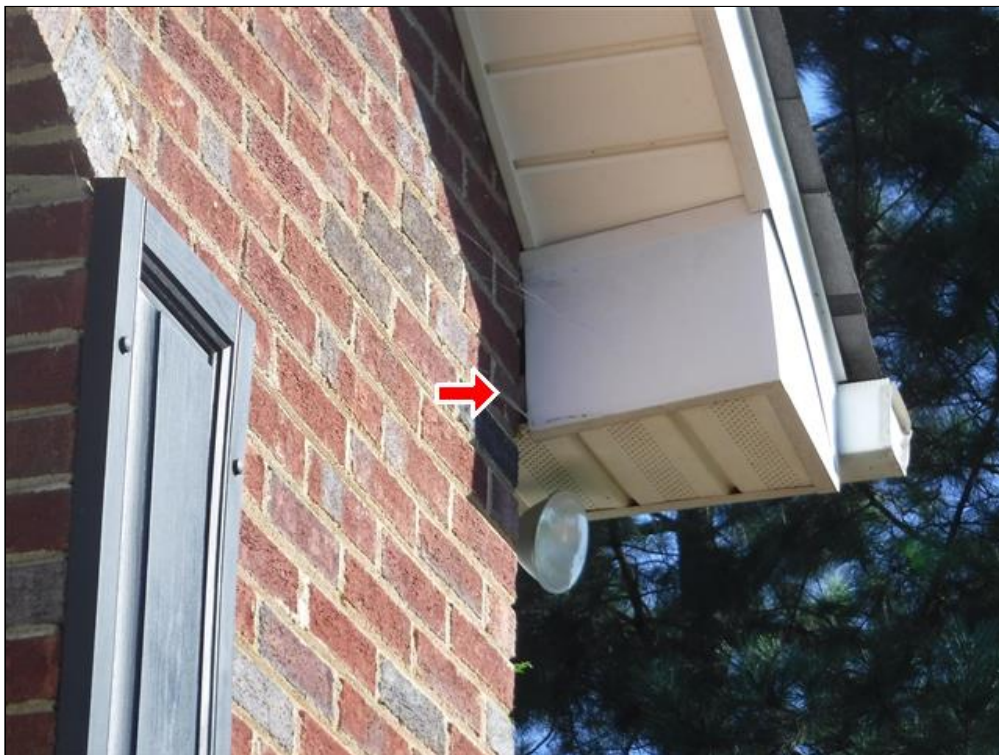
2.5 Item 1(Picture)

Piece of soffit located above far, right window in front of house is loose and needs to be reattached or replaced in order to prevent moisture and pest intrusion. A qualified contractor or tradesman should perform repair.

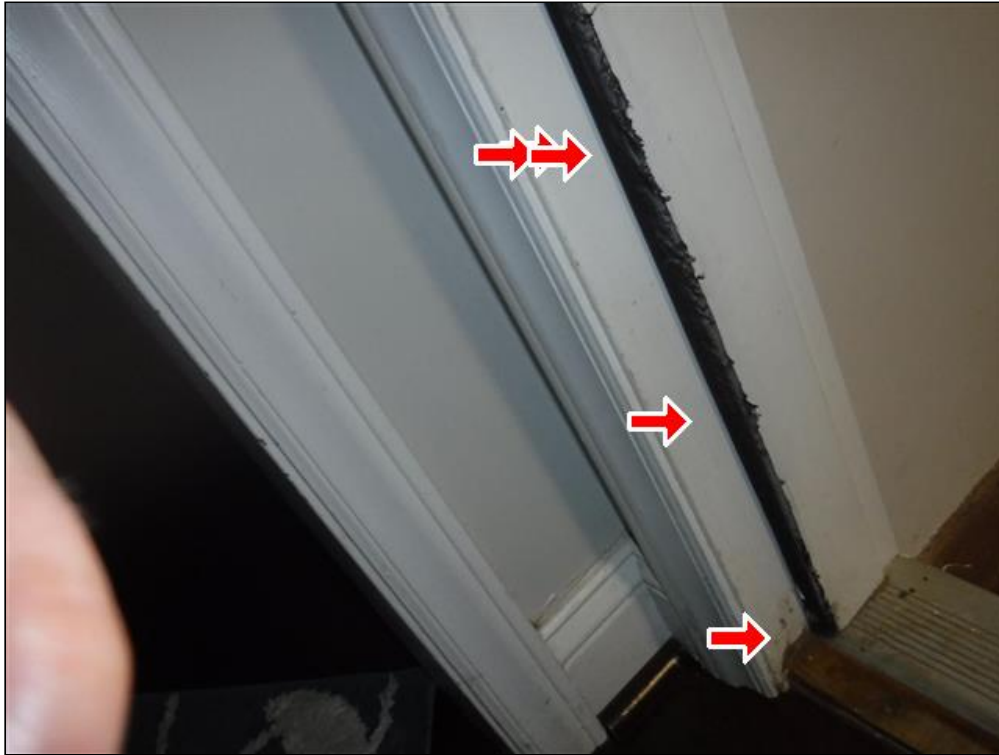
3.4 Item 1(Picture)

Weather stripping around door is damaged. Repair/replacement is recommended in order to provide adequate seal from outdoor elements. Repair should be made by qualified contractor or tradesman.

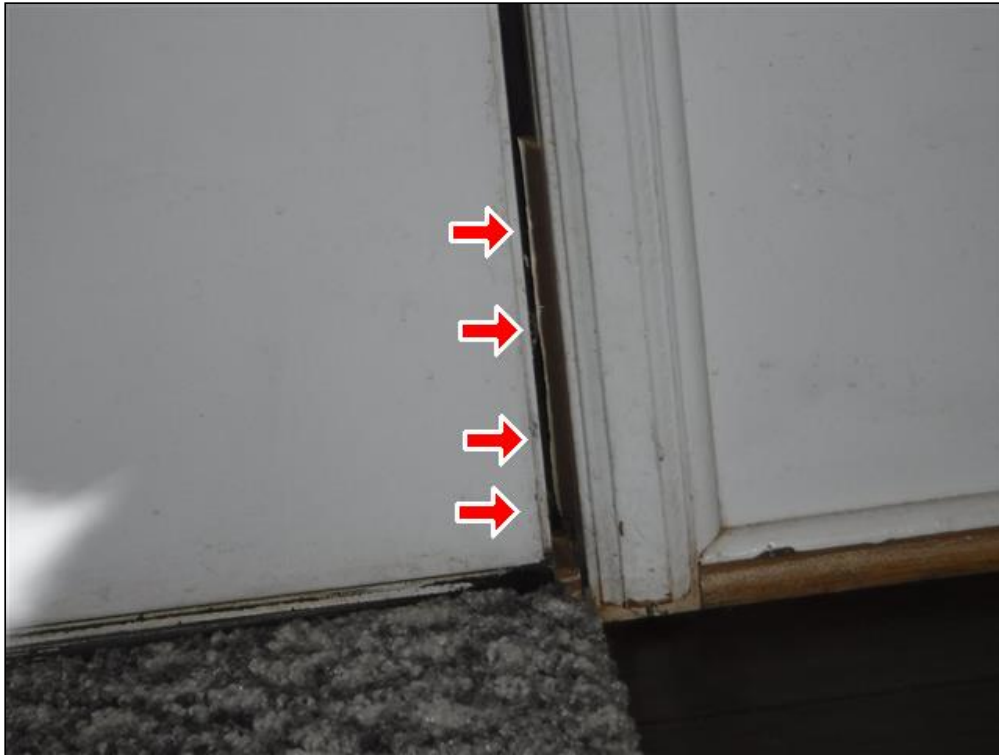
4.5 Item 1(Picture)

Weather stripping around both doors that exit to the exterior is damaged. Light from outside is clearly visible. This may lead to less efficiency of systems and general exposure to outer elements such as pests and moisture. A licensed contractor or qualified tradesman should be consulted for evaluation and repair.

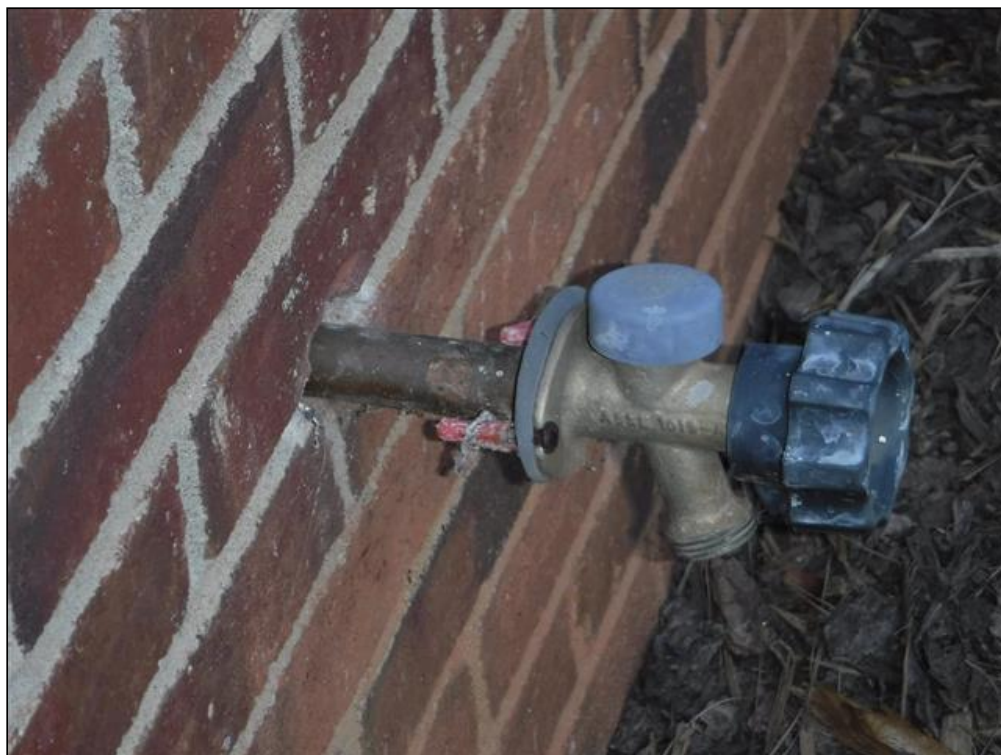
6.1 Item 1(Picture)

Hose bib located at rear of the home near the crawl space entrance has become detached from the wall. Repair needed to secure hose bib in place. A licensed plumbing contractor should perform repair.
